RBC/PW/06/2694

**CONDITION VALUATION SURVEY REPORT  
CARRIED OUT ON THE SINGLE ENGINED SEMI  
DISPLACEMENT COX 22 MOTOR FISHING CRUISER  
"JOHN BOY"**

**Date of survey :-** 22<sup>nd</sup> November 2006

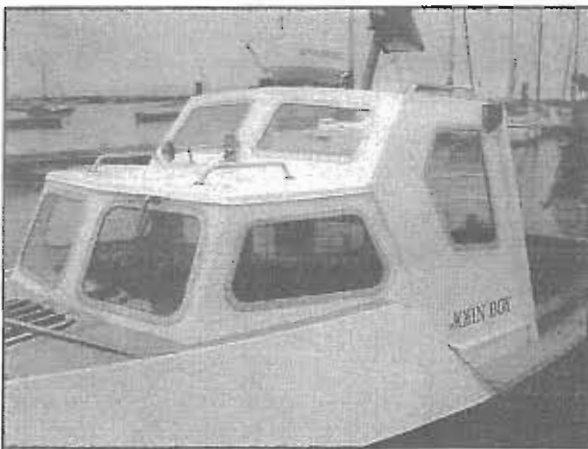
The wheelhouse, which had been modified in the refit by the addition of the raised cuddy constructed of marine plywood with hardwood framing, extending over part of the cockpit, was all seen to be in a well-painted condition. The windscreen, side and aft windows are constructed of toughened glass in alloy frames, were all seen to be secure with no signs of water ingress through seals. A recently installed electrically operated windscreen wiper fitted to the window in front of the helmsman position was found to be operating satisfactorily.

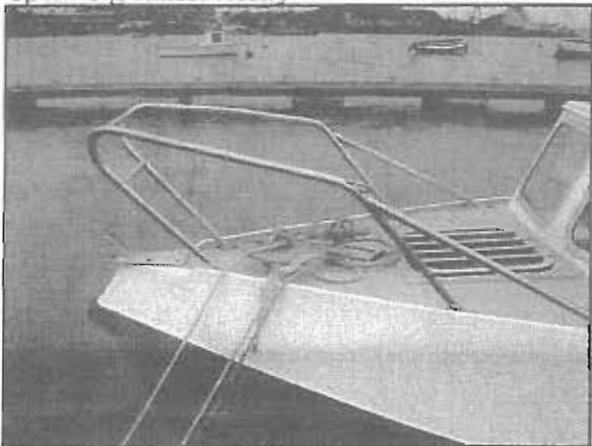
The polished stainless steel pulpit, which extends aft from the bow to the forward section of the wheelhouse, was found in sound secure order, with no distortion or other damage and the supporting legs securely bolted through the side decks. The stainless steel grab handles seen mounted on the wheelhouse and cuddy coach roof were all seen to be in secure order. The new double section polished stainless steel pushpit mounted on the aft deck extending forward to almost the cuddy was found to be securely bolt fastened through the decking, with no signs of any weakness, these having been specially made and fitted during the refit

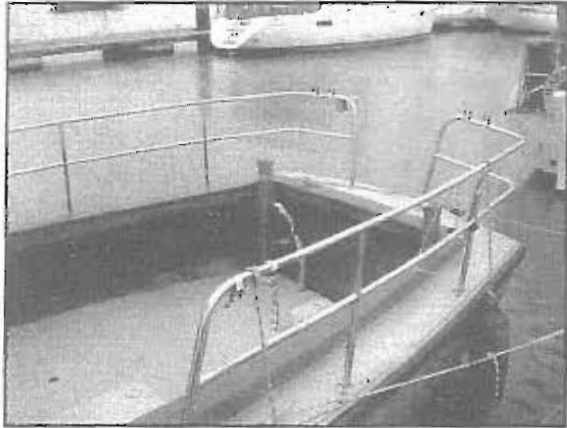
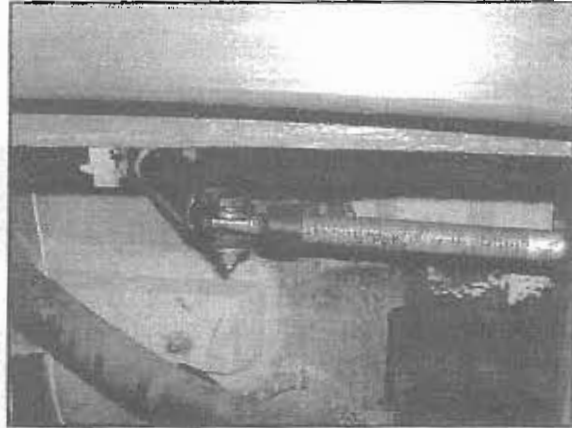
The Teleflex push/pull cable operated wheel steering mechanism was found to be operating satisfactorily, with no wear in the connecting linkages to the new stainless steel rudder stock tiller arm, having all been replaced with new. No wear was found in any of the rudder gudgeons and pintles.

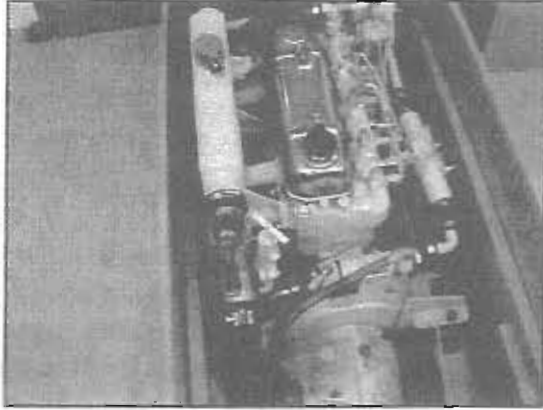
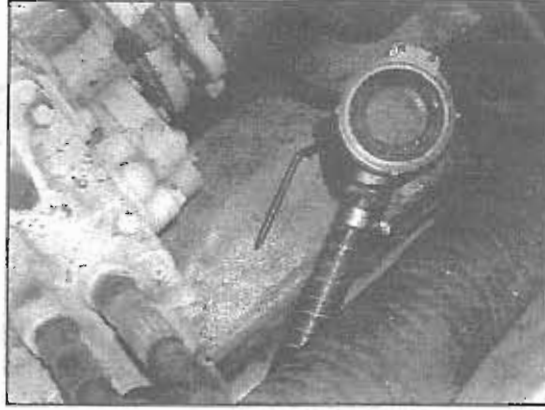
The 2.5 litre naturally aspirated 4 cylinder BMC indirectly water cooled diesel, with a

raw water cooled heat exchange, fitted with a reduction hydraulic gear box providing forward and tern drive, attached to a stainless steel shaft by standard clamp coupling. This was all seen

be in good condition having been completely overhauled.

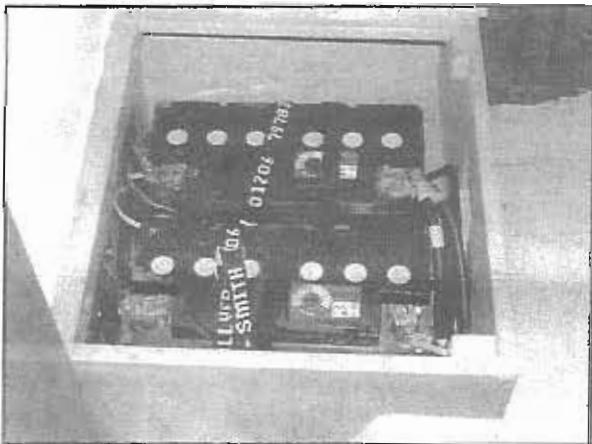
All wiring was seen to be in good condition, having all been replaced, together with a new four position master battery switch and a new switch panel. The two new batteries were found to be in a suitable secure wooden locker. Charging of the batteries is by the engine alternator.
