Yacht, Craft & Marine Surveys

RBC/PW/06/2665

**CONDITION SURVEY CARRIED OUT ON THE
WESTERLY FULMAR AUXILIARY BERMUDAN
SLOOP "SUSHA OF COLNE" ON BEHALF OF**

Date of survey :- 11th September 2006 ~~2003~~

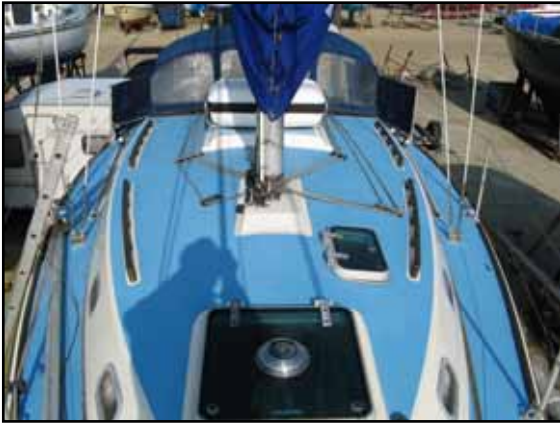
crazing, other than a small gel coat star craze on the outer section where the middle stanchion on the port side is bolted through the side deck. The non-slip areas were noted to have been painted with proprietary non-slip blue pigmented deck paint that was all seen to be in sound secure order.

sound order, although it was noted that the forward stanchion on the starboard side is leaning aft by a few degrees, but otherwise sound.

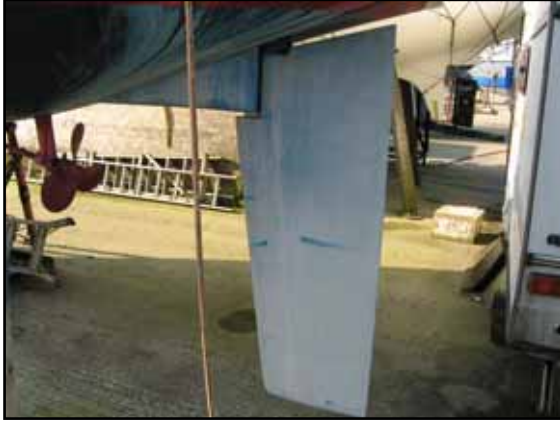
The GRP laminated moulded through hull mounted semi-balanced hydrofoil section spade rudder fitted with a stainless steel stock, was found to be in sound condition, with no signs of any damage or repair. Moisture content readings again taken with the Tramex Skipper moisture meter found very high moisture content, but no signs at of any osmotic blistering. This is a common feature with this method of rudder construction, whereby water enters the

rudder core by capillary action through the section where the stock enters the moulding. This is not normally considered a problem other than the fact that when the craft is ashore during severe freezing conditions it could cause the rudder to split. To overcome this a small hole can be drilled in the top of the rudder blade and one near the bottom allowing any water to drain out during the winter and then plugging with silicone mastic before re launching. This plug can then be removed when next laid up.

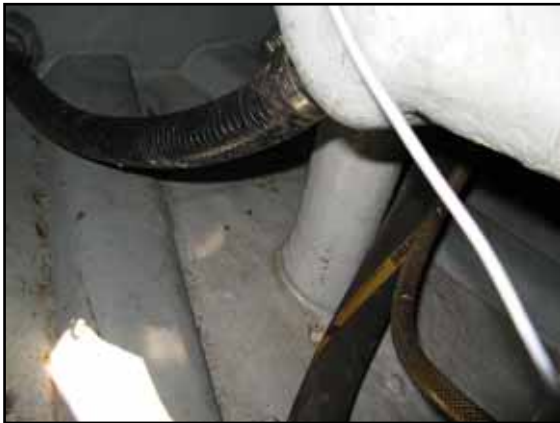
Slight fore and aft wear was found in the lower plastic rudder stock bush, but was not sufficient to be considered a problem and furthermore, when the craft is again immersed in water the plastic expands by a small amount, which will possibly take up any slight apparent movement. Internally the laminated rudder stock tube was found in secure order, with no signs of any weakness or water ingress where laminated to the hull.

Movement of the rudder is achieved by a teak tiller with an alloy extension arm, which was seen to be in sound order and well varnished condition and suitably attached to the stock by a stainless steel hinged head. No wear was found in the stainless steel hinge bolt, but slight movement was found where the hinged head is secured to the top of the rudderstock by a large nut, above

which is a split pin to prevent the nut coming off. The nut was found to be loose and therefore in need of tightening.

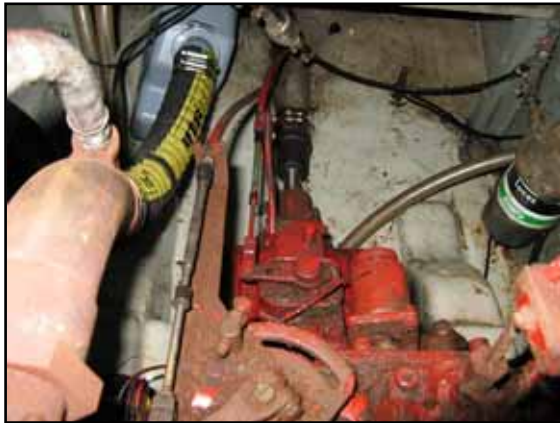
present moment the rubber seal may have hardened during the years that the craft has

been laid up ashore. Therefore will need to be closely watched when craft is launched. It should also be noted with this class of inner seal that before the propeller shaft is allowed to revolve when first launched, that the seal be squeezed to expel all air from within the stern shaft tube until water exudes, to enable the seal to be water lubricated. Failure to do so could cause damage to the seal.

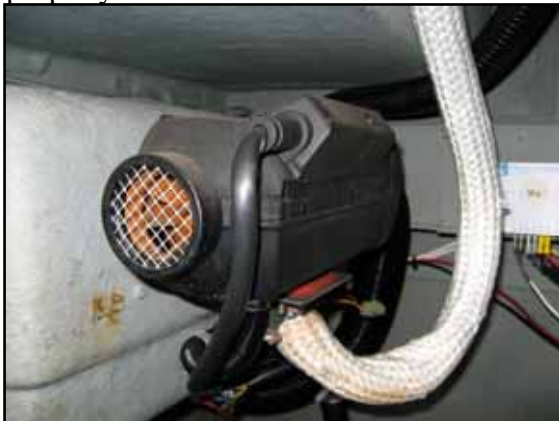
Heating is provided by an Eberspacher oil-fired ducted hot air system, with the burner unit located in the starboard cockpit locker. This was found to be in clean condition properly installed and secure. When tested in the heating mode it would start, but cut off

after approximately 10 seconds. This would indicate a faulty igniter or in need of servicing, having not been used for a long period. When used in the cool fan position it was found working.
