Report of Condition Survey Carried out on the yacht

“ZENITH”

PRE-PURCHASE CONDITION SURVEY REPORT ON YACHT

Vessel Type: Deben 4-Tonner auxiliary gaff cutter
Year: 1936
LOA: 25' 9" inc. bowsprit
LOD: 22'
Beam: 7' 3"
Draught: 3' 9"
Construction: Carvel-planked pitch pine on oak framing
Designer: William Maxwell Blake
Builder: Whisstocks of Woodbridge (not verified)
Registration: None
Rig: Gaff Cutter
Engine: Yanmar 1 GM-10

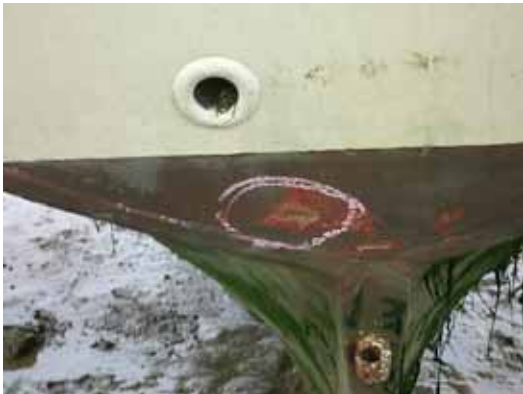
A very small area of softening was noted on the transom below the waterline (ringed in adjacent photograph). The paint coating in this area was poorly-adhered and the timber behind saturated and beginning to soften. This softening appears localised, and when next ashore it is recommended that the coatings in this area be removed to allow further investigation/ drying. It is felt that if allowed to dry thoroughly, a satisfactory repair can be made using epoxy resin without the need for letting in a graving piece.

Recommendation: Remove coatings to allow softened area of transom to thoroughly dry, and repair localised softening with epoxy resin.

3. Remove coatings to allow softened area of transom to thoroughly dry, and repair localised softening with epoxy resin.
