Yacht, Craft & Marine Surveys

RBC/PW/06/2665

**CONDITION SURVEY CARRIED OUT ON THE
WESTERLY FULMAR AUXILIARY BERMUDAN
SLOOP "SUSHA OF COLNE" ON BEHALF OF**

Date of survey :- 11th September 2006 ~~2003~~

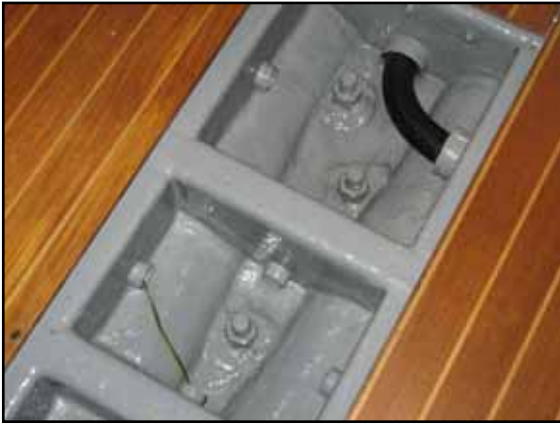
All the upper sections of the keel bolts could be examined internally and these were found to be suitably fitted with stainless steel backing plates bedded on mastic. All were seen to be in a secure condition, with no indications of any rust. It was noted that the bilges were very clean and dry having been painted with a grey bilge paint.

The external mastic used to bed the keel to the moulded hull stub was found to be sound, and there were no signs of any rust on the iron keel, but possibly small rust blisters beneath the old anti-fouling paint. None of was considered a problem.

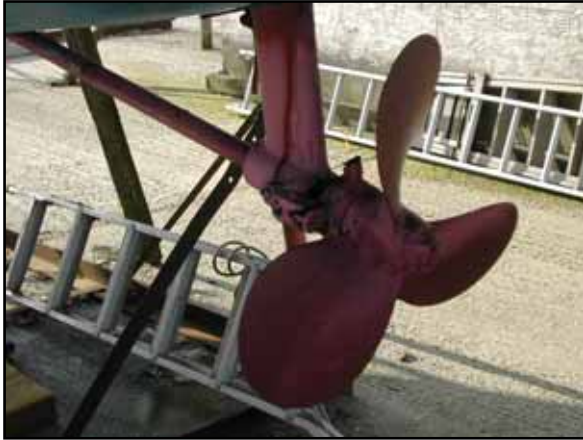
The three bladed fixed bronze propeller was found in good condition and properly secured and locked to the stainless steel propeller shaft and fitted with a proprietary rope cutter. The rubber cutlass bearing in the "P" bracket showed no signs of wear. The inner seal is provided by a rubber Volvo type. This was seen to be in good order with no signs of any excessive previous water ingress. Although appearing sound at the

present moment the rubber seal may have hardened during the years that the craft has

been laid up ashore. Therefore will need to be closely watched when craft is launched. It should also be noted with this class of inner seal that before the propeller shaft is allowed to revolve when first launched, that the seal be squeezed to expel all air from within the stern shaft tube until water exudes, to enable the seal to be water lubricated. Failure to do so could cause damage to the seal.

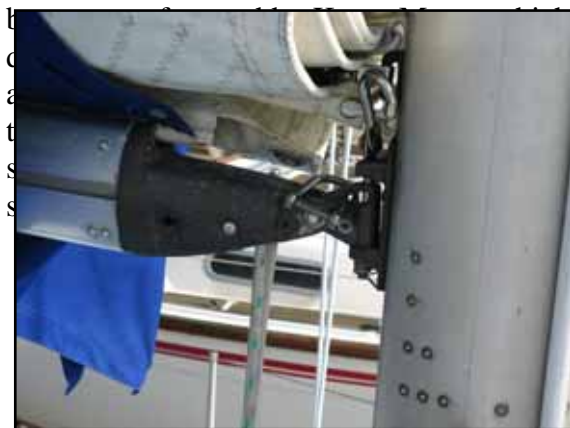
had to be inspected through binoculars from good condition and the silver anodising sound showing no signs of excessive wear and attachment secure. The mast is fitted with alloy spreaders mounted in alloy sockets in secure sound condition, but individual

fastenings could not be studied. Masthead crane was seen to be in good order, together with the alloy heel fitted with turning blocks to enable all halyards and reefing lines to be led aft back to the cockpit. All reinforced slots for the Gibb type swaged rigging ends showed no evidence of any weakness.

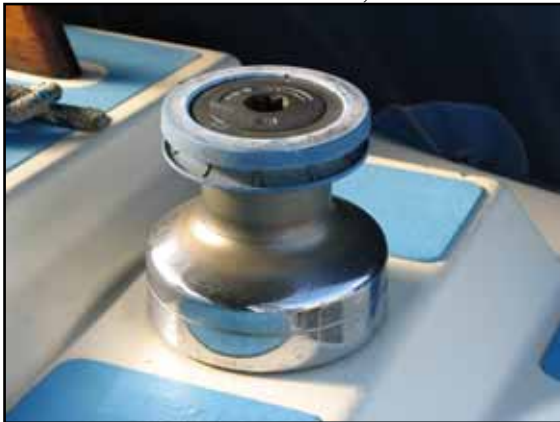
Both the Barlow 21 two speed sheet and halyard winches, with rubber cappings to enable self tailing, mounted on the aft section of the saloon cabin coach roof and the two Barlow 19 two speed halyard winches also mounted on the aft section of the saloon cabin coach roof were found secure and working satisfactorily, but unable to test under load.

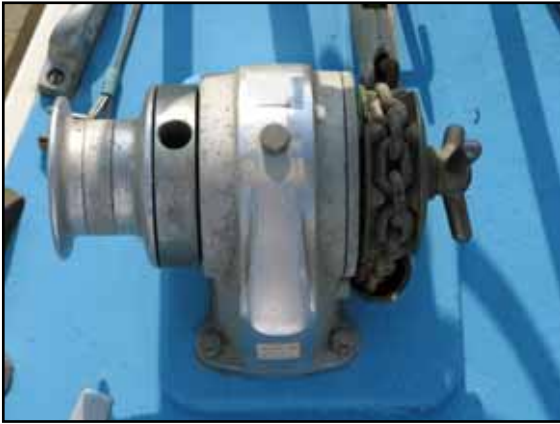
A further 20 lb plough kedge anchor attached to a short length of chain and an unmeasured length of multi-plat nylon warp seen and found to be in good order

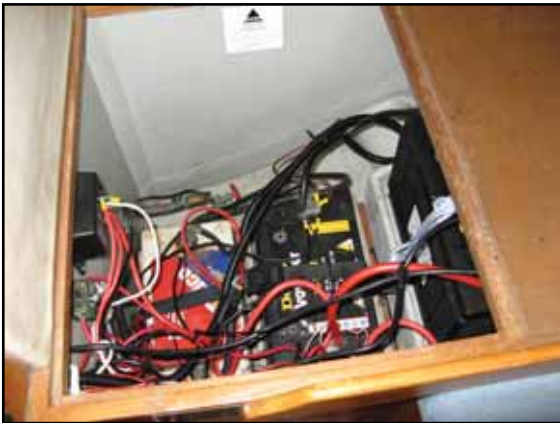
Three lead acid batteries are contained beneath the quarter berth were seen to be in good condition and suitably strapped. Charging of the batteries is achieved by the engine alternator or alternatively when main shore power is connected through the

in built battery charger. It was also noted that the craft is fitted with an Adverc battery management system.

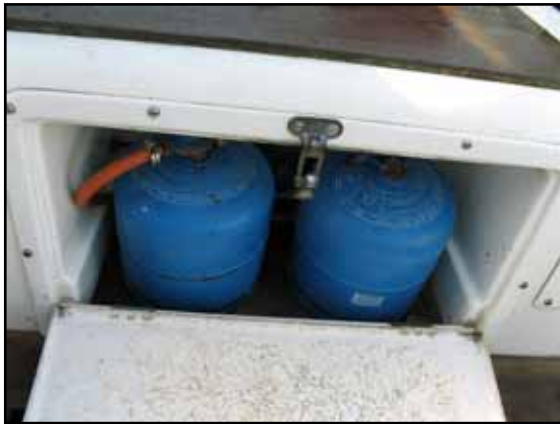
The gas installation, consisting of gas cylinder storage in the self-contained starboard hand cockpit locker was seen to be in order, and the flexible piping from the cylinder to the fixed copper piping complying with BS 3212 and showing a date of 2003. The flexible piping at the cooker from the gas stopcock also to BS 3212 was seen to be new, having only just have been replaced, but this was showing a date of March 1997. Unfortunately there

is not much they can be done in these circumstances when this situation arises, caused by Chandler's purchasing large quantities of the piping, but only selling in small lengths over a number of years. Having had assurances that this is in order from the Chandlers as no gas has been used in the pipe, no replacement is necessary. As far as it was possible to inspect the fixed copper piping was seen to be properly clipped and showing no adverse corrosion.

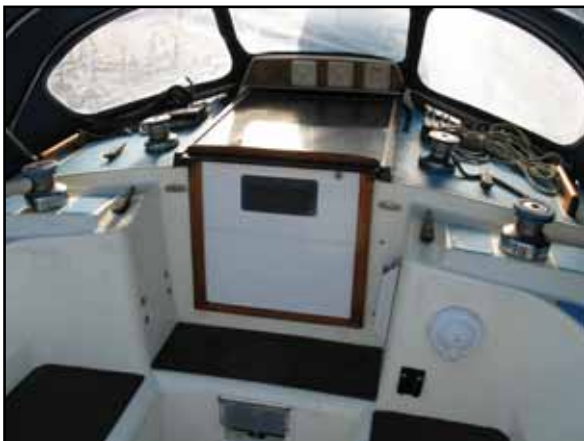
The stainless steel fresh water tank seen located beneath cockpit sole aft of the engine all seen to be in good condition and secure. Aft of at the fresh water tank is a diesel fuel tank, which could not be closely studied but all appeared to be in order and suitably fitted with a shut off valve.

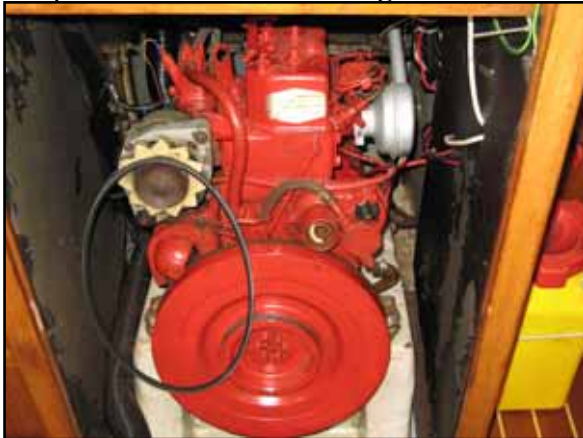
The Bukh DV20 twin cylinder 20 hp directly water-cooled diesel engine appeared to be in a clean well maintained serviced condition. An engine does not form part of a craft survey and therefore if considered suspect, it should be inspected by an accredited Agent or specialist marine diesel engineer. Unable to hear engine running.

The engine beds were examined and found in order and the engine mounts found sound, although slightly rusty, but could not be examined whilst engine running. No alignment checks possible but seemed in order.

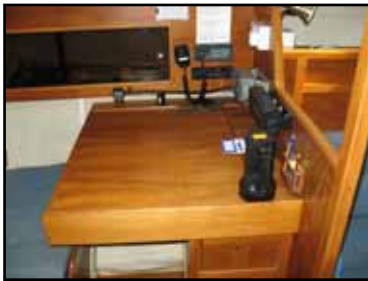
CHART TABLE:-

Located to port adjacent to the companionway steps forming part of the navigation station.

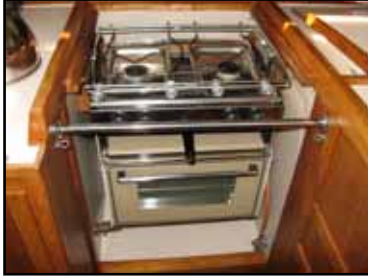
COOKER :-

Gimballed Plastimo Neptune 2000 gas cooker, fitted with 2 burners grill and oven and seen in good clean condition. Fitted with gas stopcock adjacent to cooker.

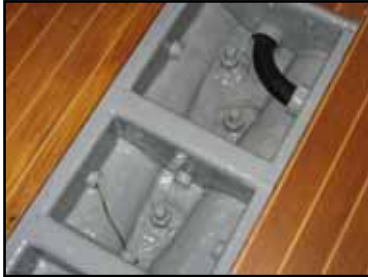
FLOORS :-

Substantial laminated box section floors extending the full width of the cabin soles laminated to the hull and found secure.

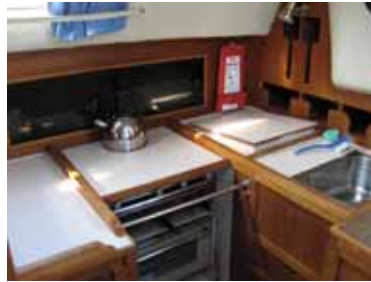
GALLEY :-

Located to starboard adjacent to companionway. Consisting of a laminate worktop fitted with a stainless steel sink served by a foot pumped fresh cold water faucet with lockers and draws beneath,

a refrigerated cool box and a gimbaled gas cooker.

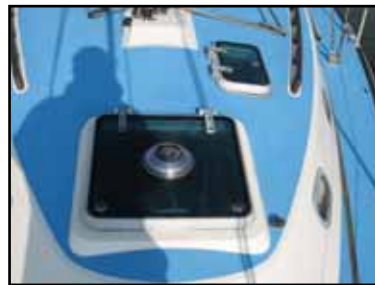
HATCHES :-

Main hatch is of sliding tinted acrylic with alloy runners. Washboards of white opaque acrylic in slotted teak runners, secured by twist key operated latch.

Fore hatch hinged is a Lewmar alloy framed acrylic
